**TEST AND EVALUATION OF AN EXPERIMENTAL FEASIBILITY
PROTOTYPE PASSIVE SEAT MOUNTED LIMB RESTRAINT SYSTEM**

Marcus Schwartz
Aircraft and Crew Systems Technology Directorate
NAVAL AIR DEVELOPMENT CENTER
Warminster, Pennsylvania 18974

20 May 1981

PHASE REPORT
AIRTASK NO. 1F41-400-000
Work Unit No. ZA61D
Program Element No. 62241N

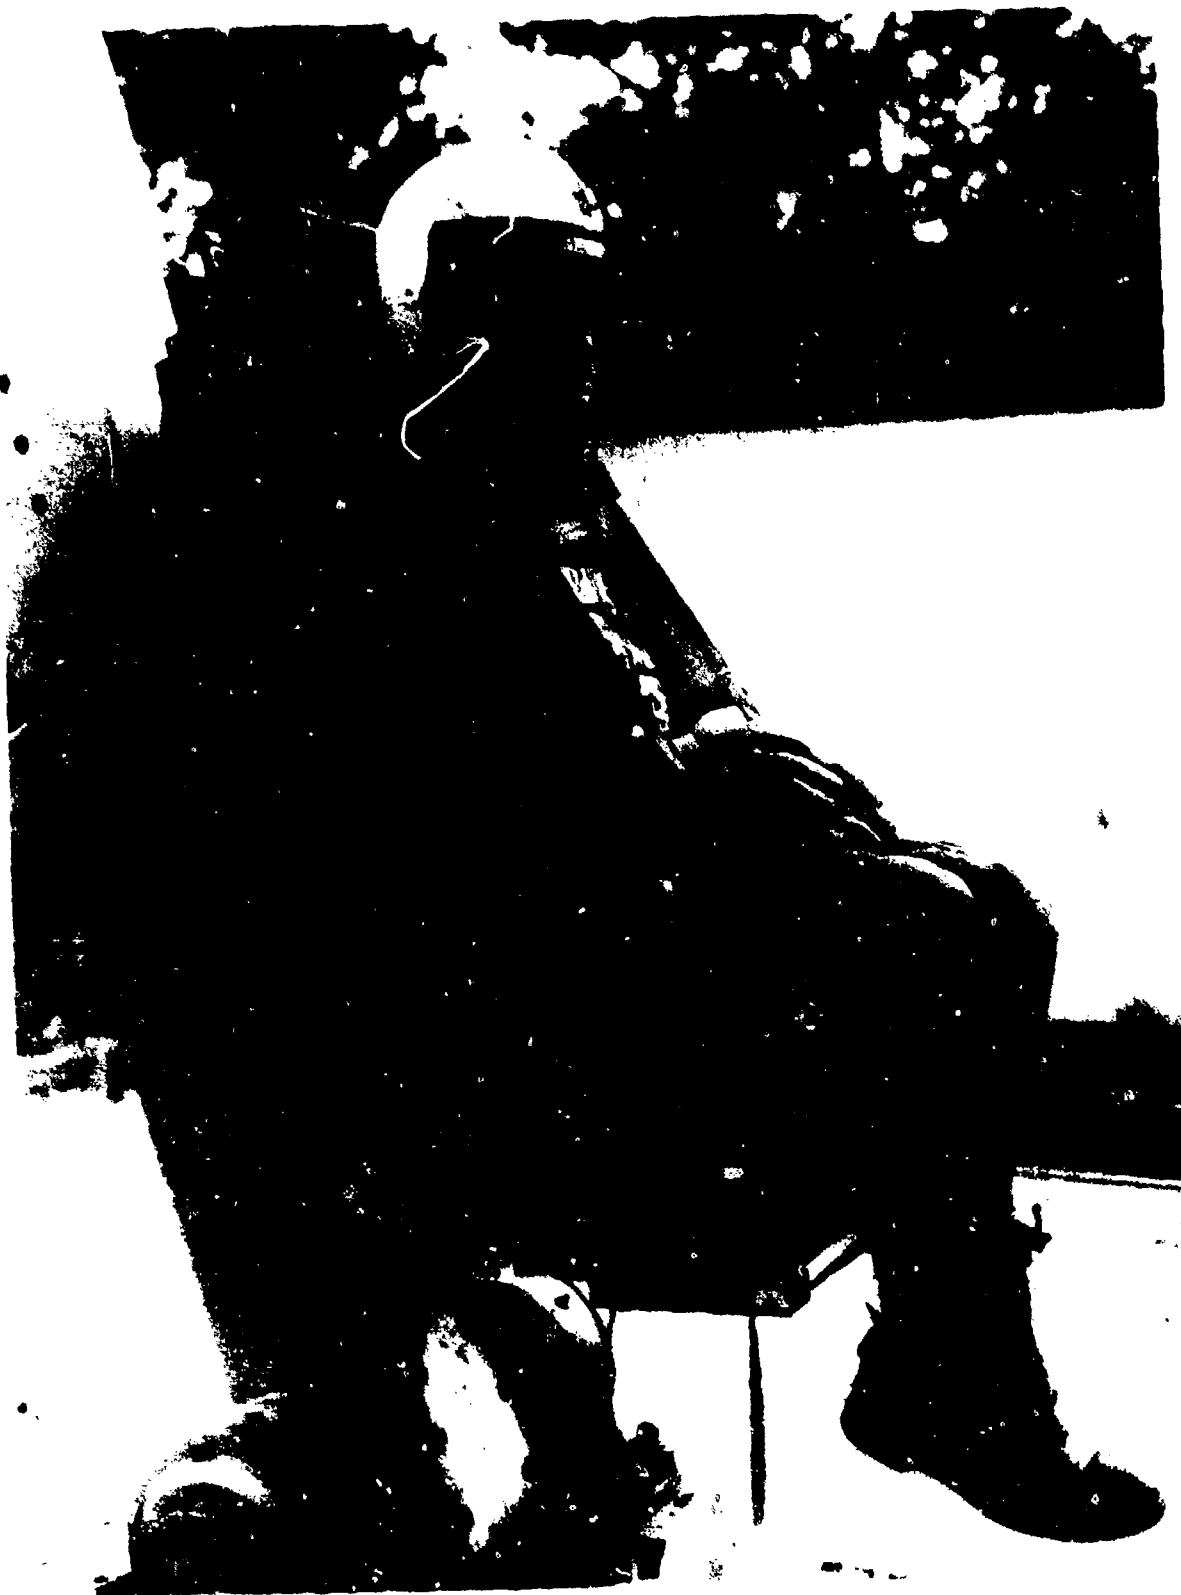
FIGURE 14 - Windblast Test Set-Up - Head - On

The set-up for this test is shown in figure 14. The seat was installed at a nominal 17 degree angle to conform to a typical installation position. The restraint system was pretensioned prior to each test. During this 477 knot exposure, the arms moved down to the seat sides (figure 15) but were adequately trapped by the arm nets. The legs were also adequately restrained. Following the test, it was discovered that the restraint lines were tensioned to only 200 lb. instead of the required 400 lb. This would explain the reason the arms moved down from the initial ejection position between the legs. However, the limbs were considered adequately restrained. An examination of the restraint system, dummy, and seat showed no evidence of damage nor any injury potential to the occupant.

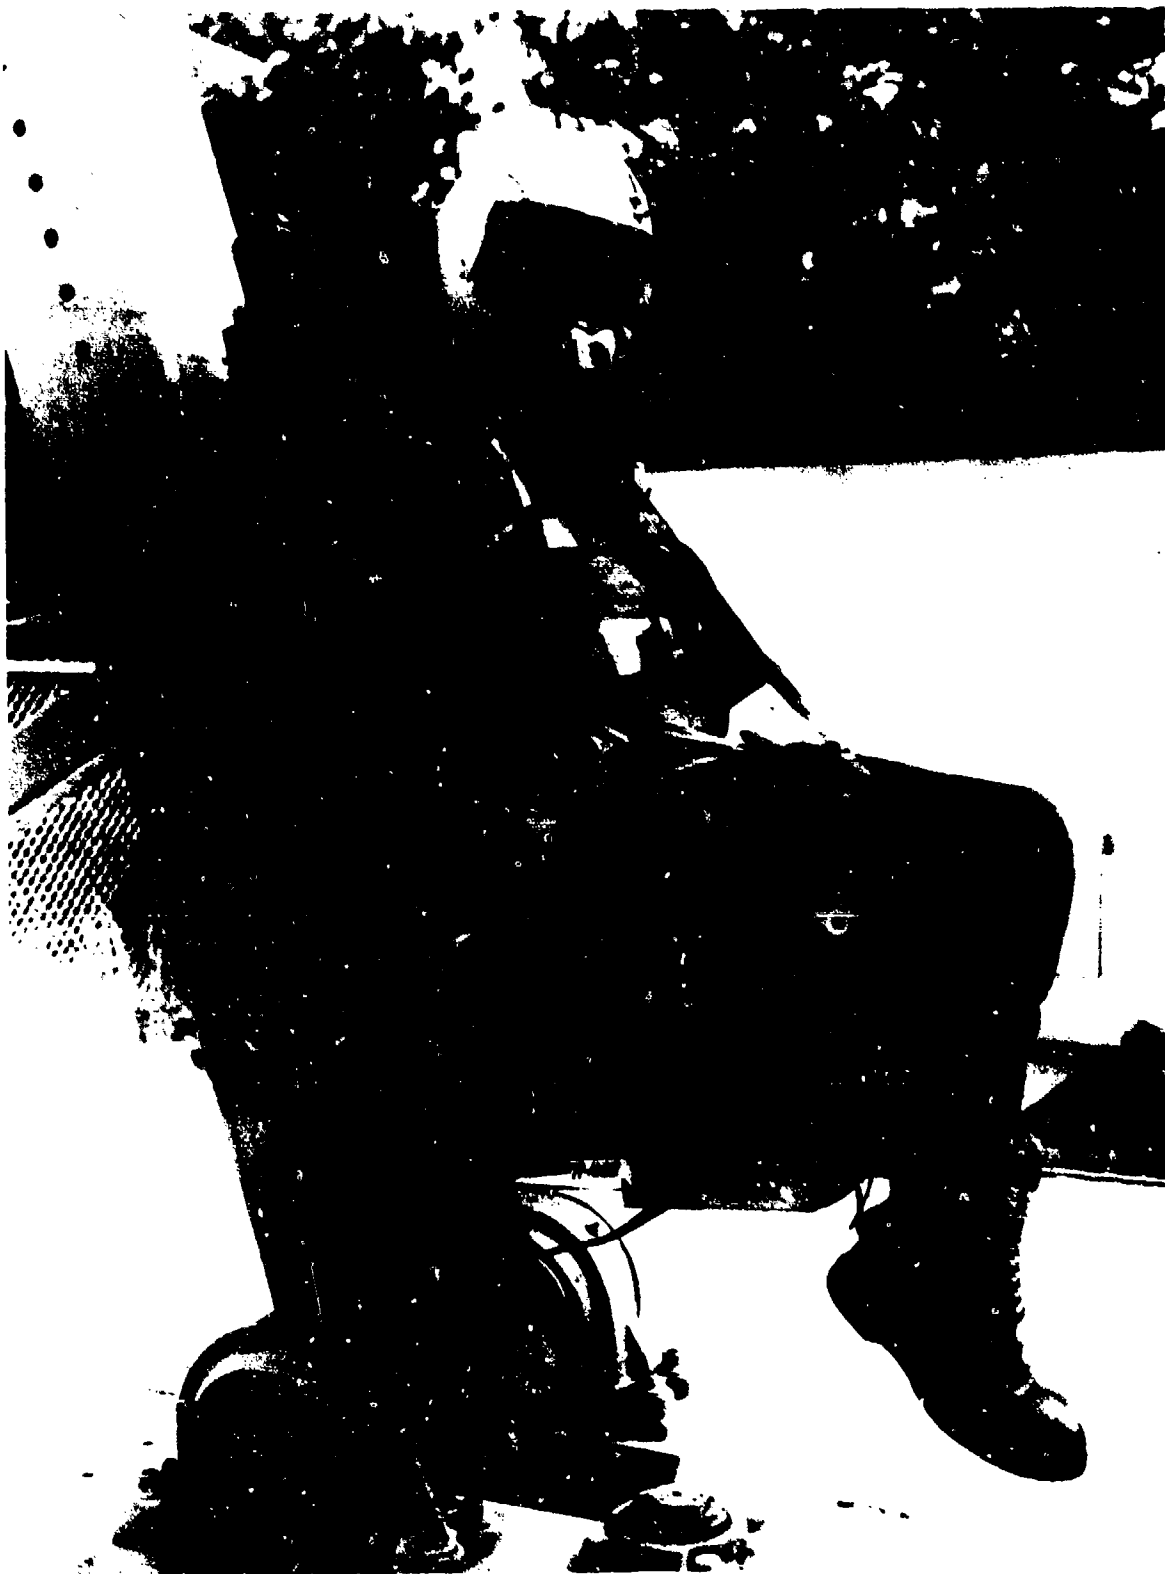
FIGURE 15 - Post Test Condition - Head - On

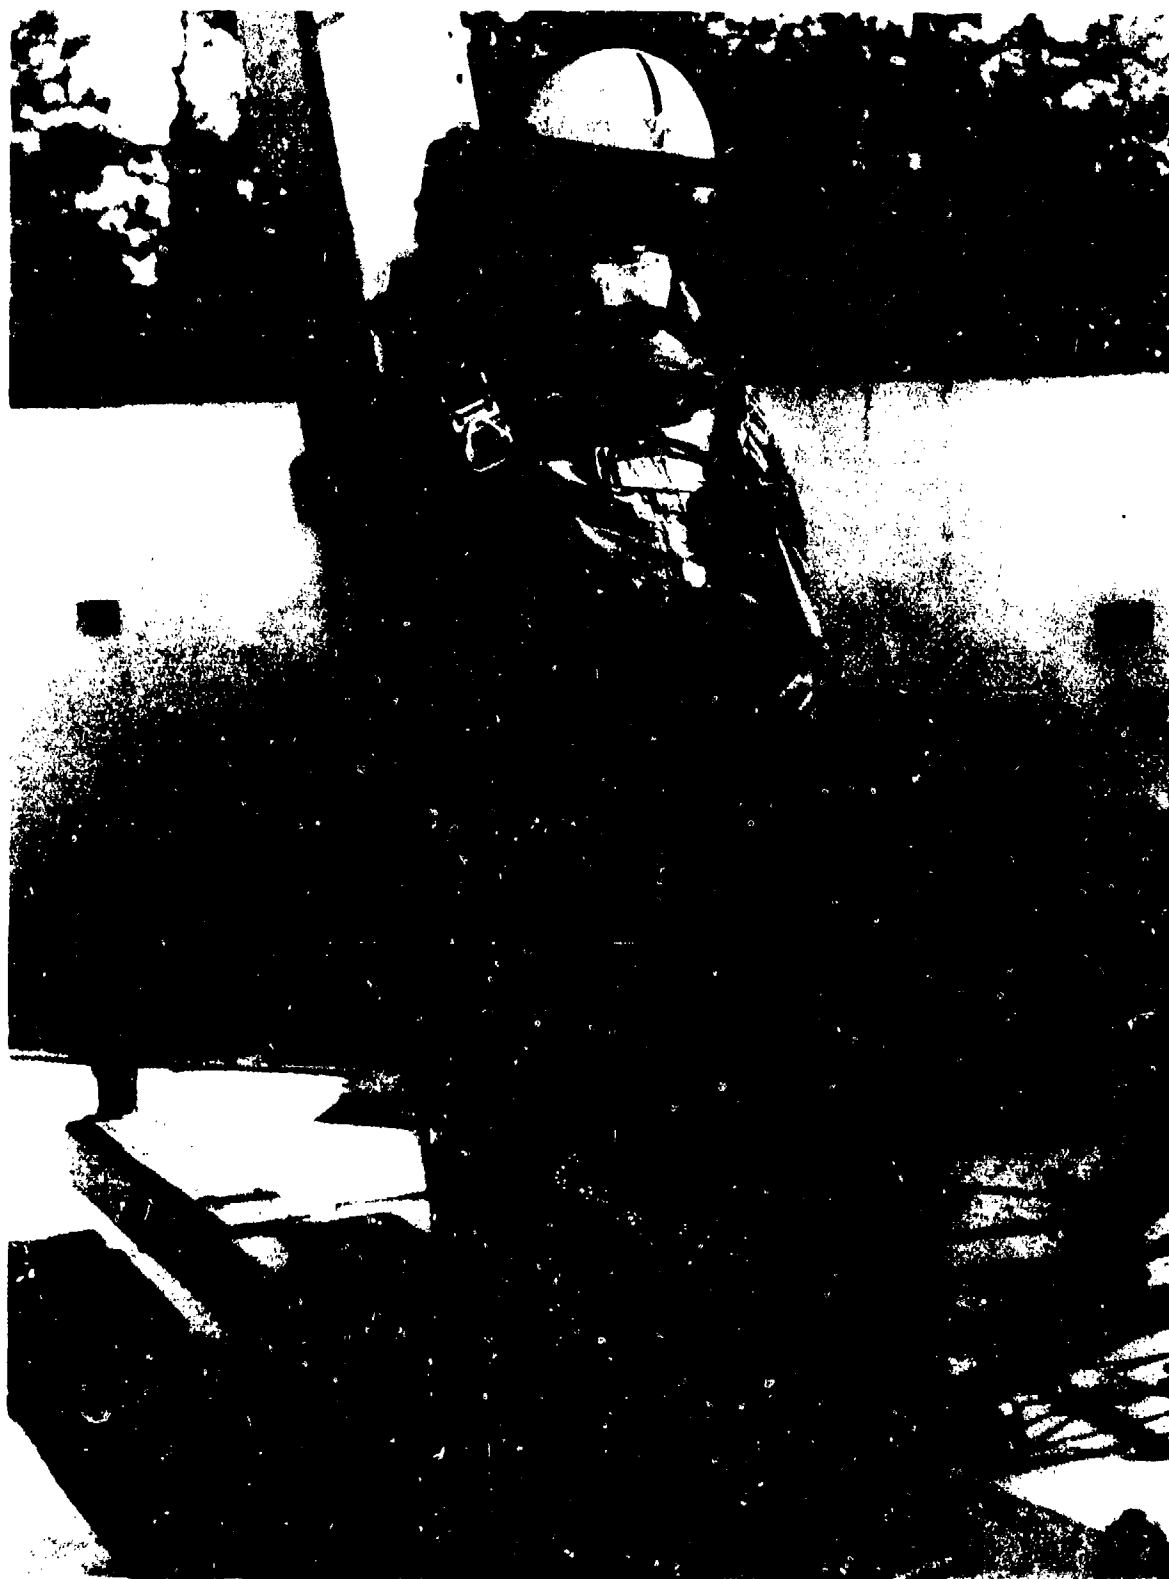
FIGURE 20 - Post Test Condition - Yaw 45 Degrees Starboard

The only motion observed was the slight movement of the dummy's legs in the direction of the windblast, as would be expected, but still adequately restrained (figure 20). The test was repeated on the port side with similar successful results.

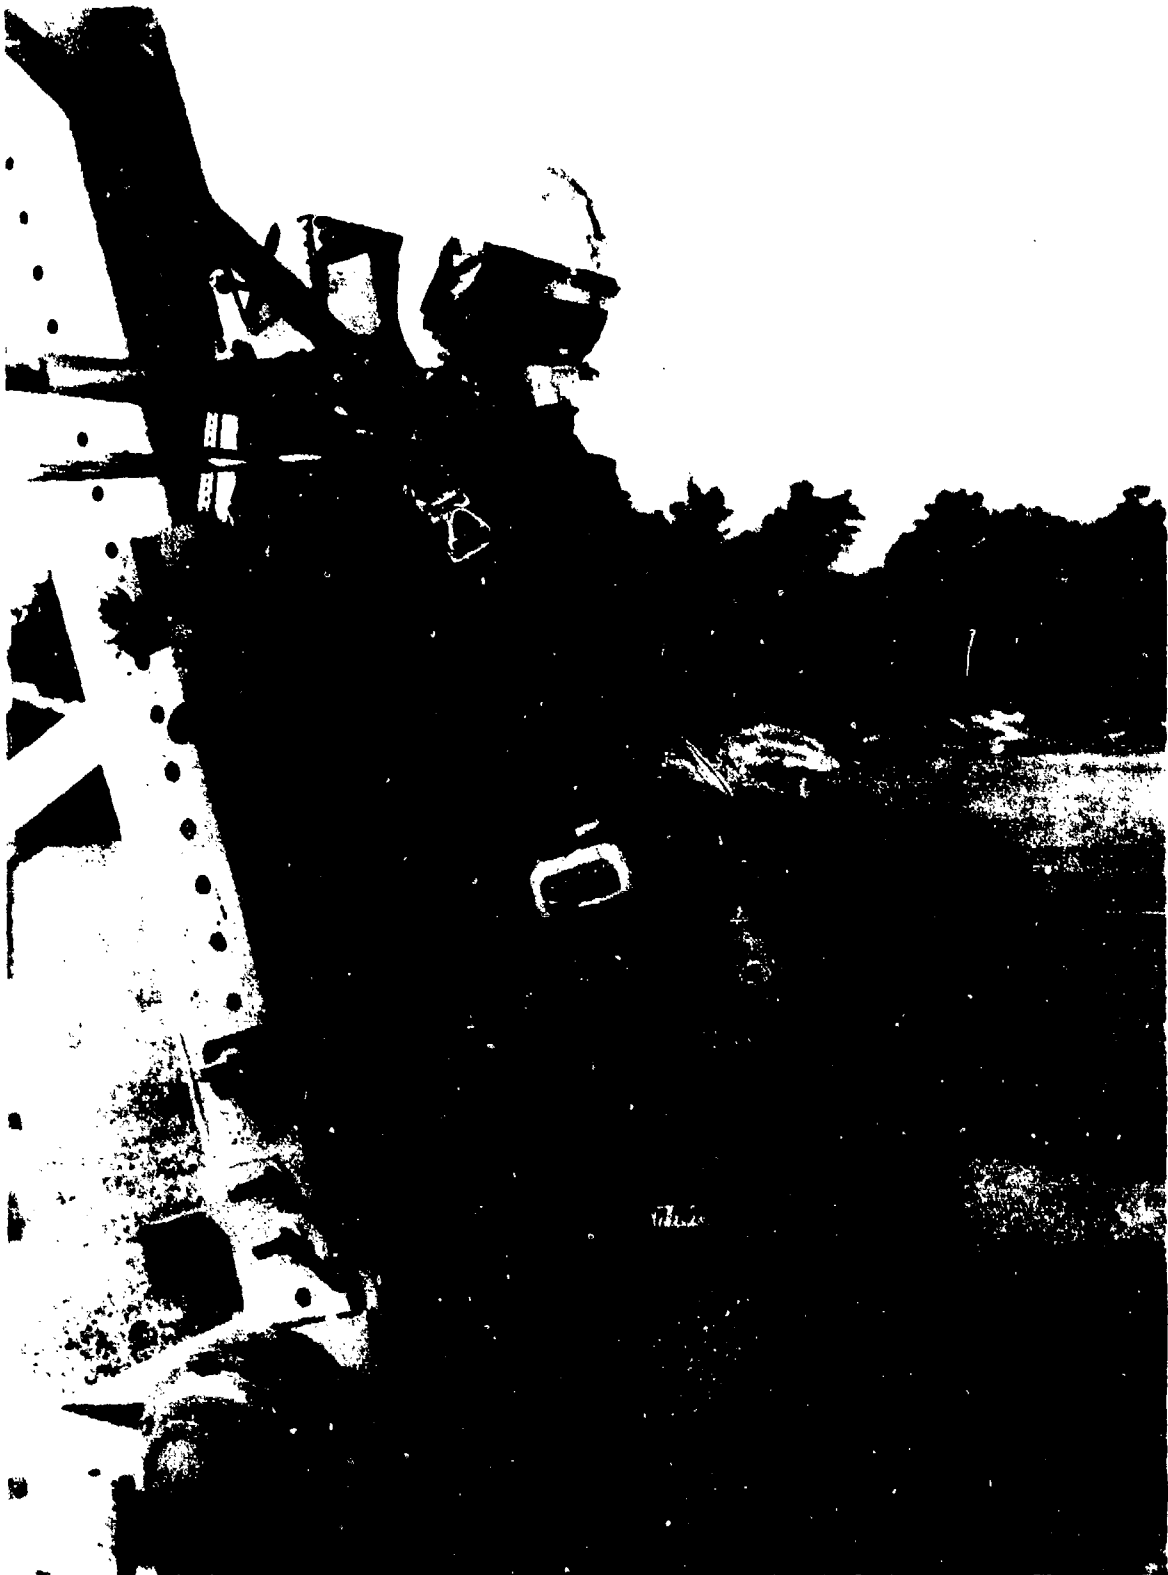
FIGURE 21 - Windblast Test Set-Up - Yaw 90 Degrees Port

Following the successful 45-degree yaw test, the seat was rotated to a full 90-degree yaw position relative to the air nozzles (figure 21).

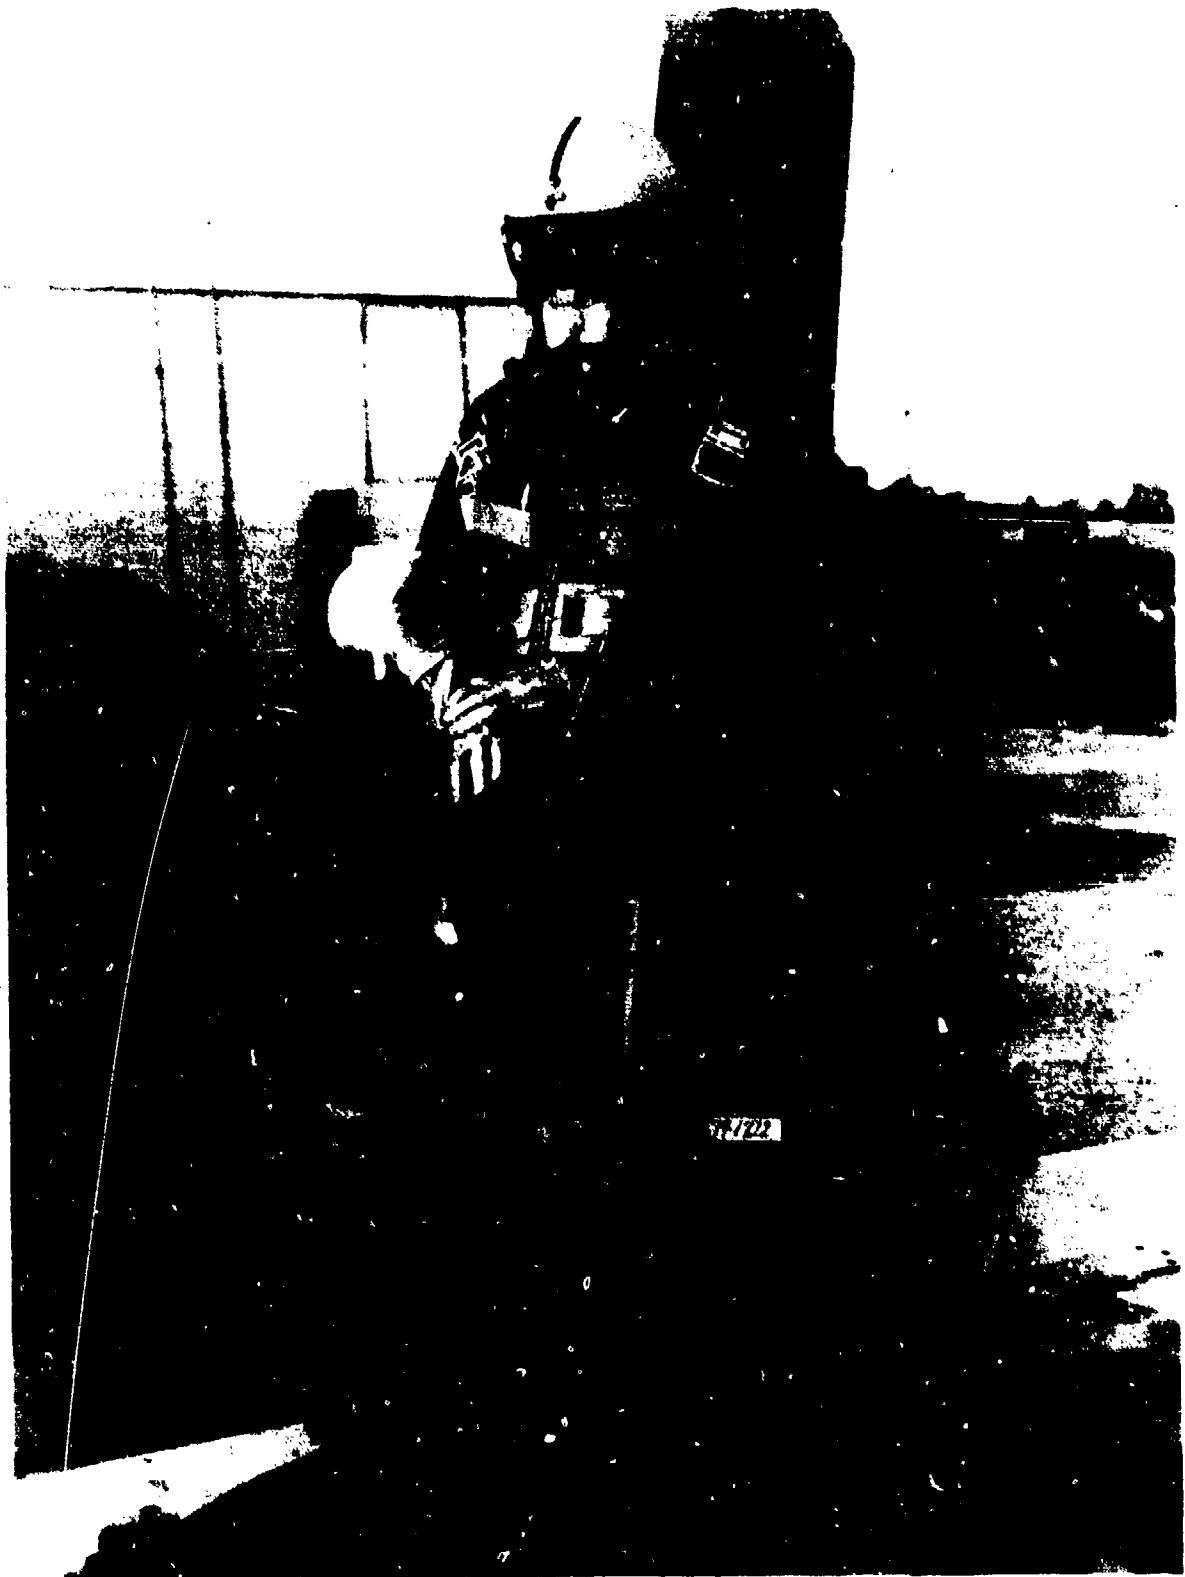
FIGURE 23 - Windblast Test Set-Up - 45 Degree Yaw - 537 Knots

The seat was positioned again at 45 degrees yaw to the port side (figure 23).

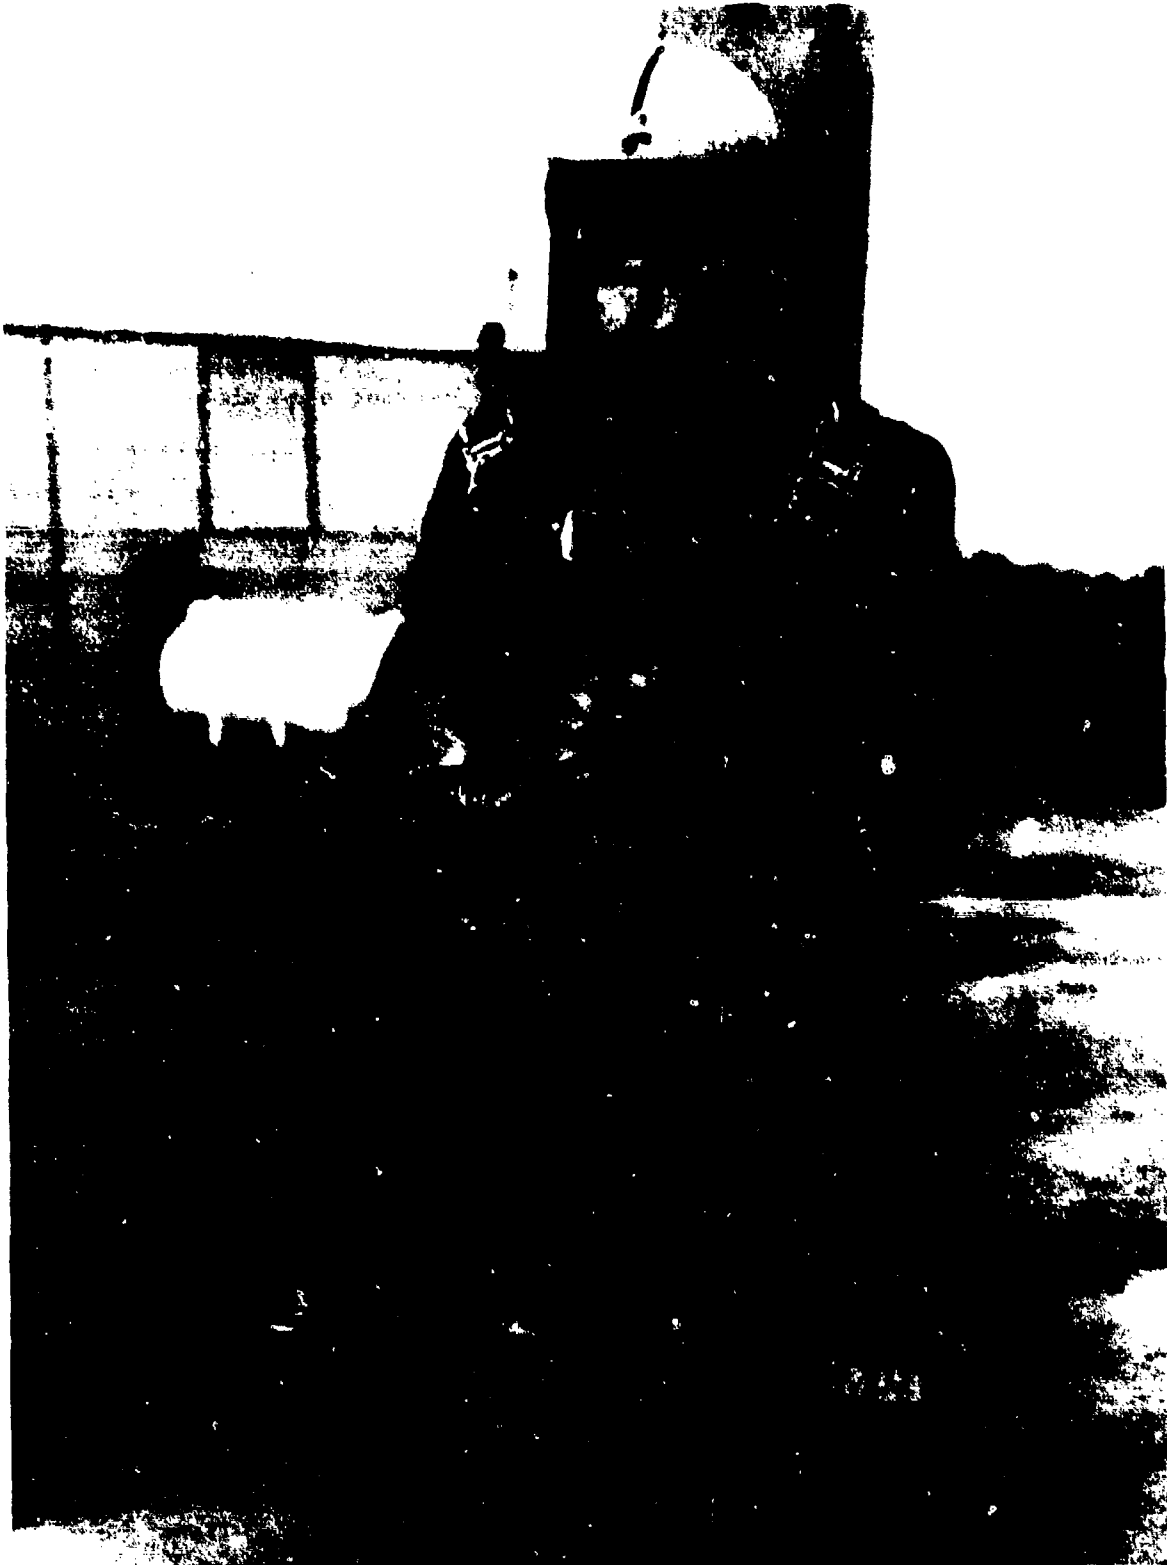
FIGURE 24 - Post Test Condition - 45 Degree Yaw - 537 Knots

After resetting the strap tension loads in the leg lines, the system was subjected to a 550-knot windblast exposure. The system was examined immediately after the test and the dummy's limbs were found to be perfectly restrained and secured in the ejection position. Subsequent analysis of the high-speed film coverage confirmed the adequacy of the restraint configuration to protect and secure the limbs for this condition. As before, the only motion in the dummy was some slight sideways motion of one leg in the direction of the windblast (figure 24).

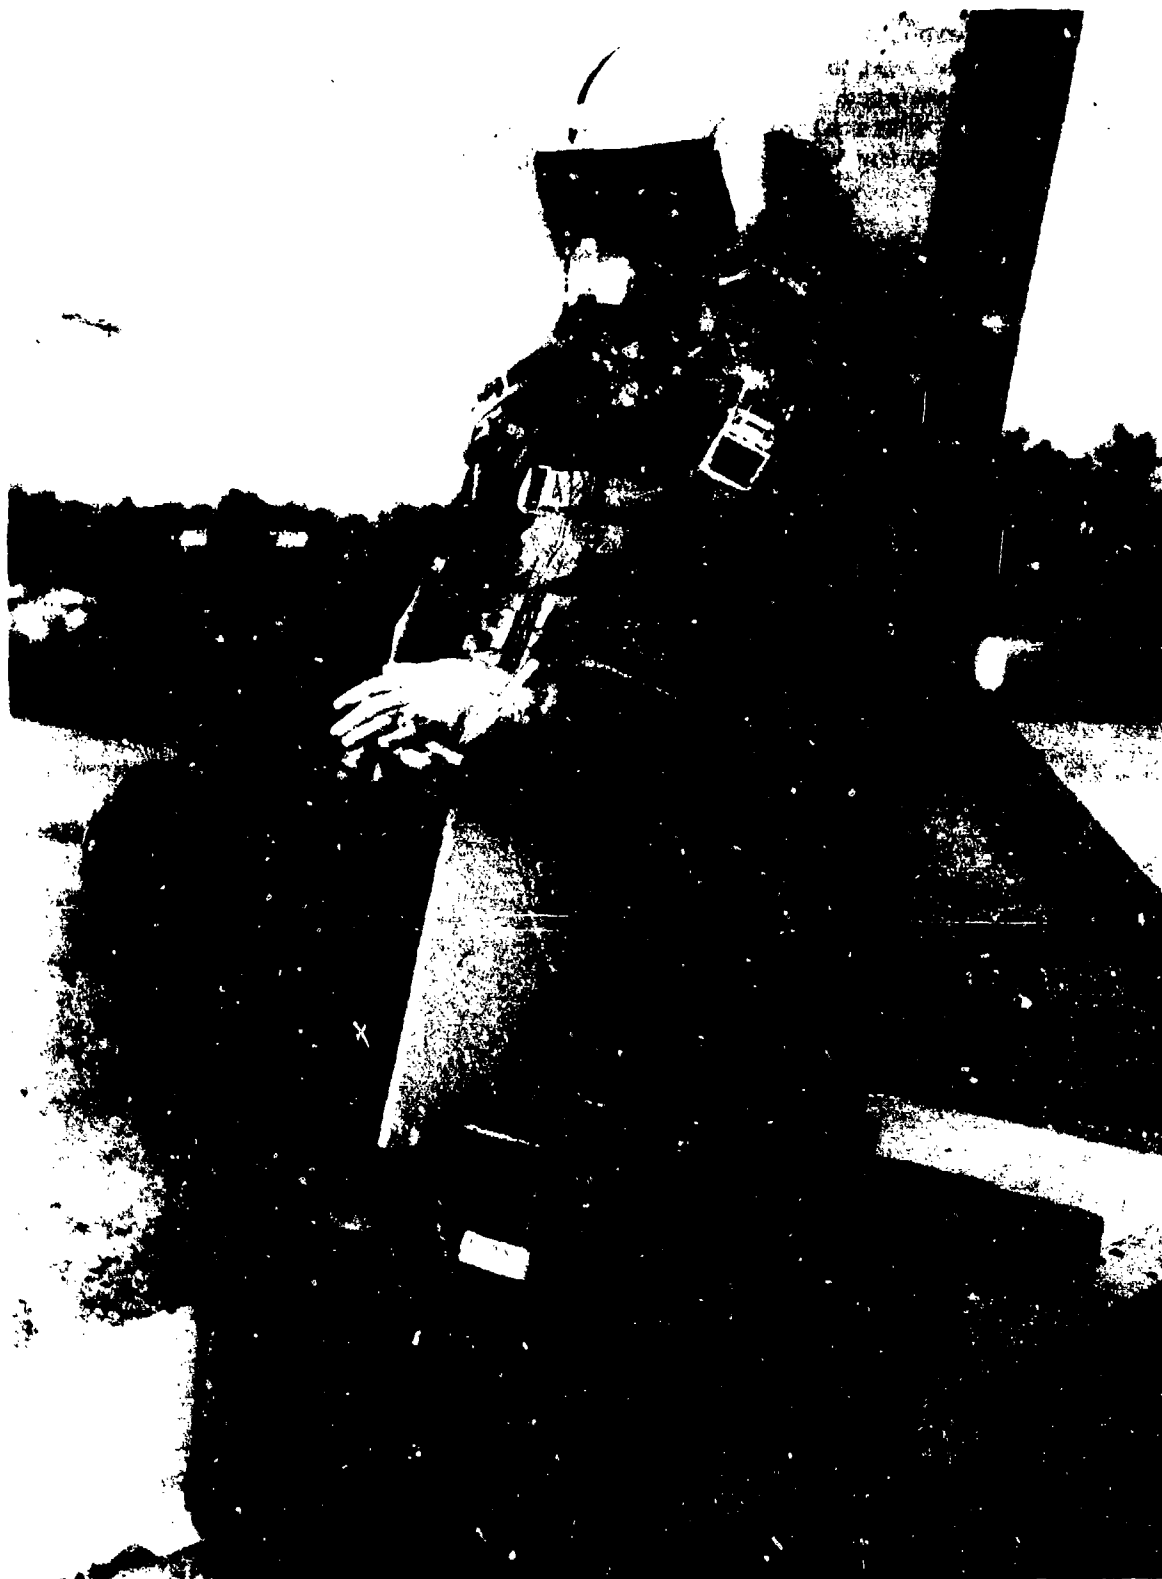
FIGURE 25 - Windblast Test Set-Up - Head - On 605 Knots

The final test of the windblast series was a 600K level exposure. The seat was positioned at the nominal 17-degree seat back angle and straight ahead to the windblast direction (figure 25). As before, the restraint line tension loads were checked prior to the test. The right hand line was easily tensioned to the 400-lb. level and locked via the snubber. The left hand restraint line was also tensioned to the 400-lb. level, but it was not readily locked in place via the snubber when the applied tensioning load was released. The snubber was only able to be locked after some slippage of line as the load was being released. After several unsuccessful attempts to lock the snubber at the 400-lb. load level, it was necessary to allow the snubber to lock at a lower level, (which was not observable) but was estimated at about 300 lbs.

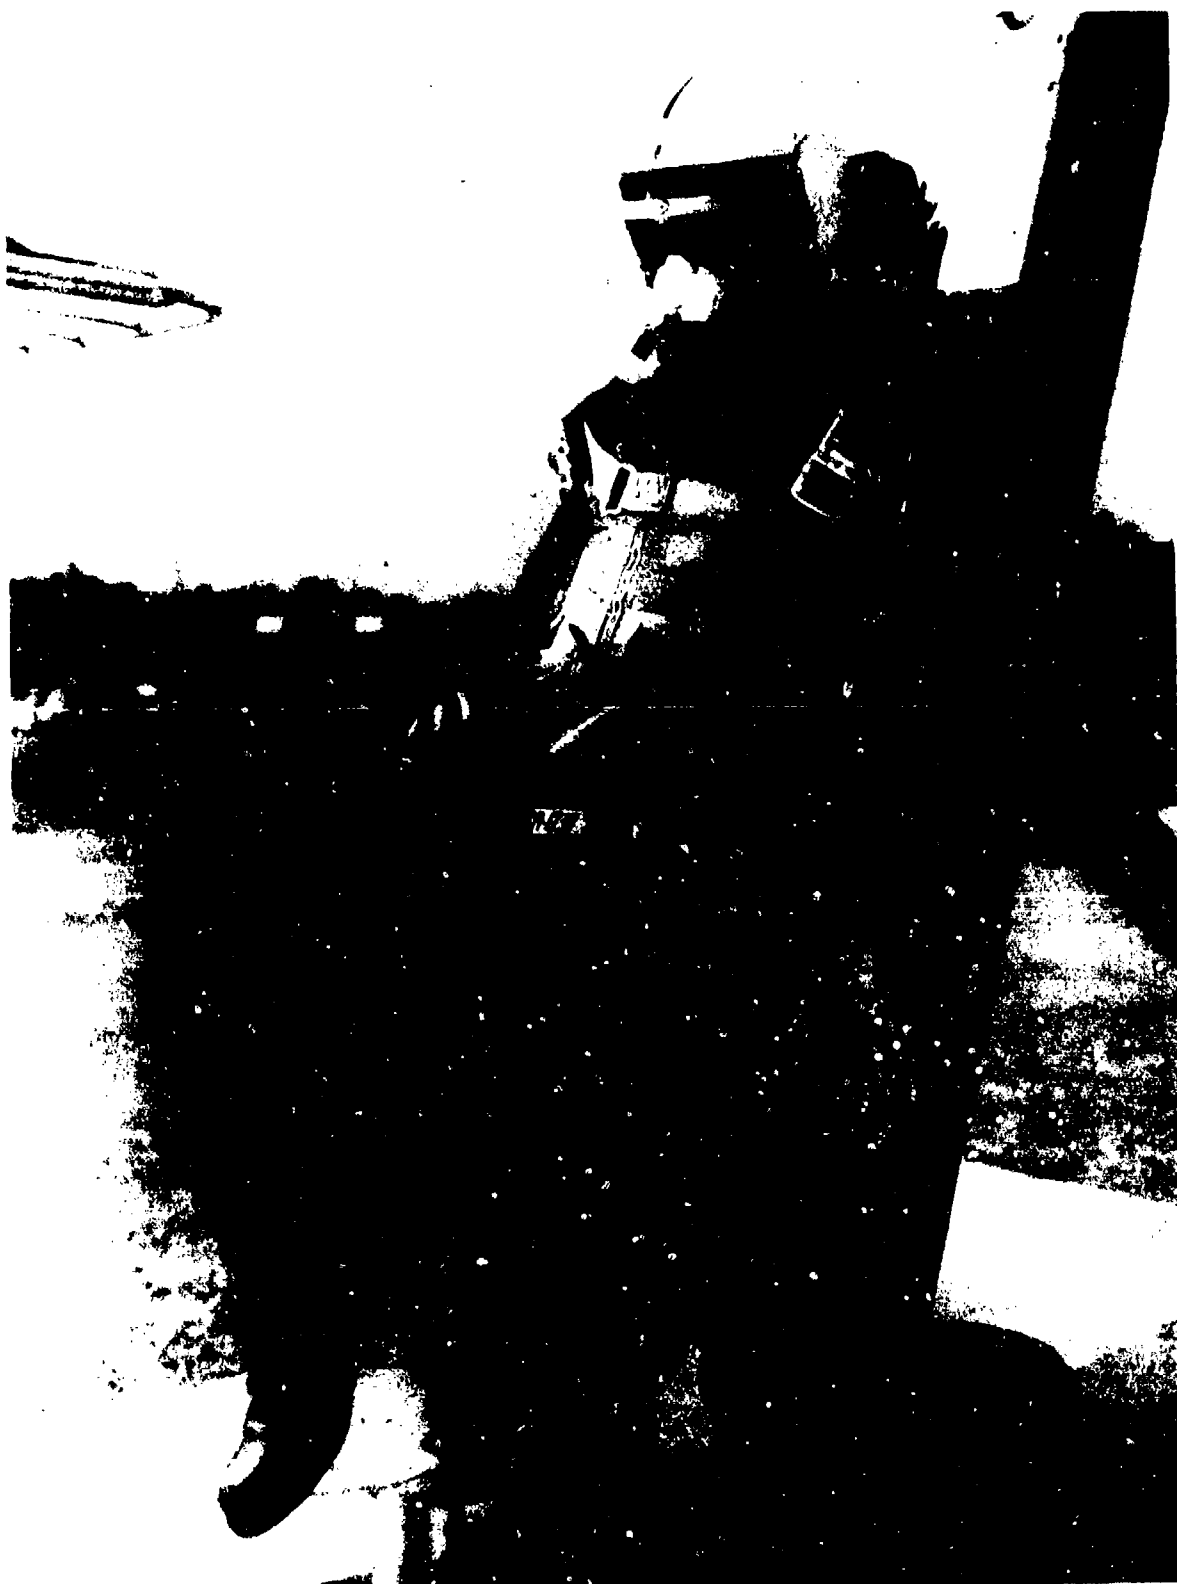
FIGURE 26 - Post Test Condition 605 Knots Port Side

At peak exposure, the dummy's left arm translated down approximately parallel to the seat back (figure 26), but was still entrapped by the arm net. The arm was prevented from flailing. The obvious reason for this arm motion was due to the extra slack allowed in the restraint line because of the problem with locking the snubber at the 400-lb. load level.

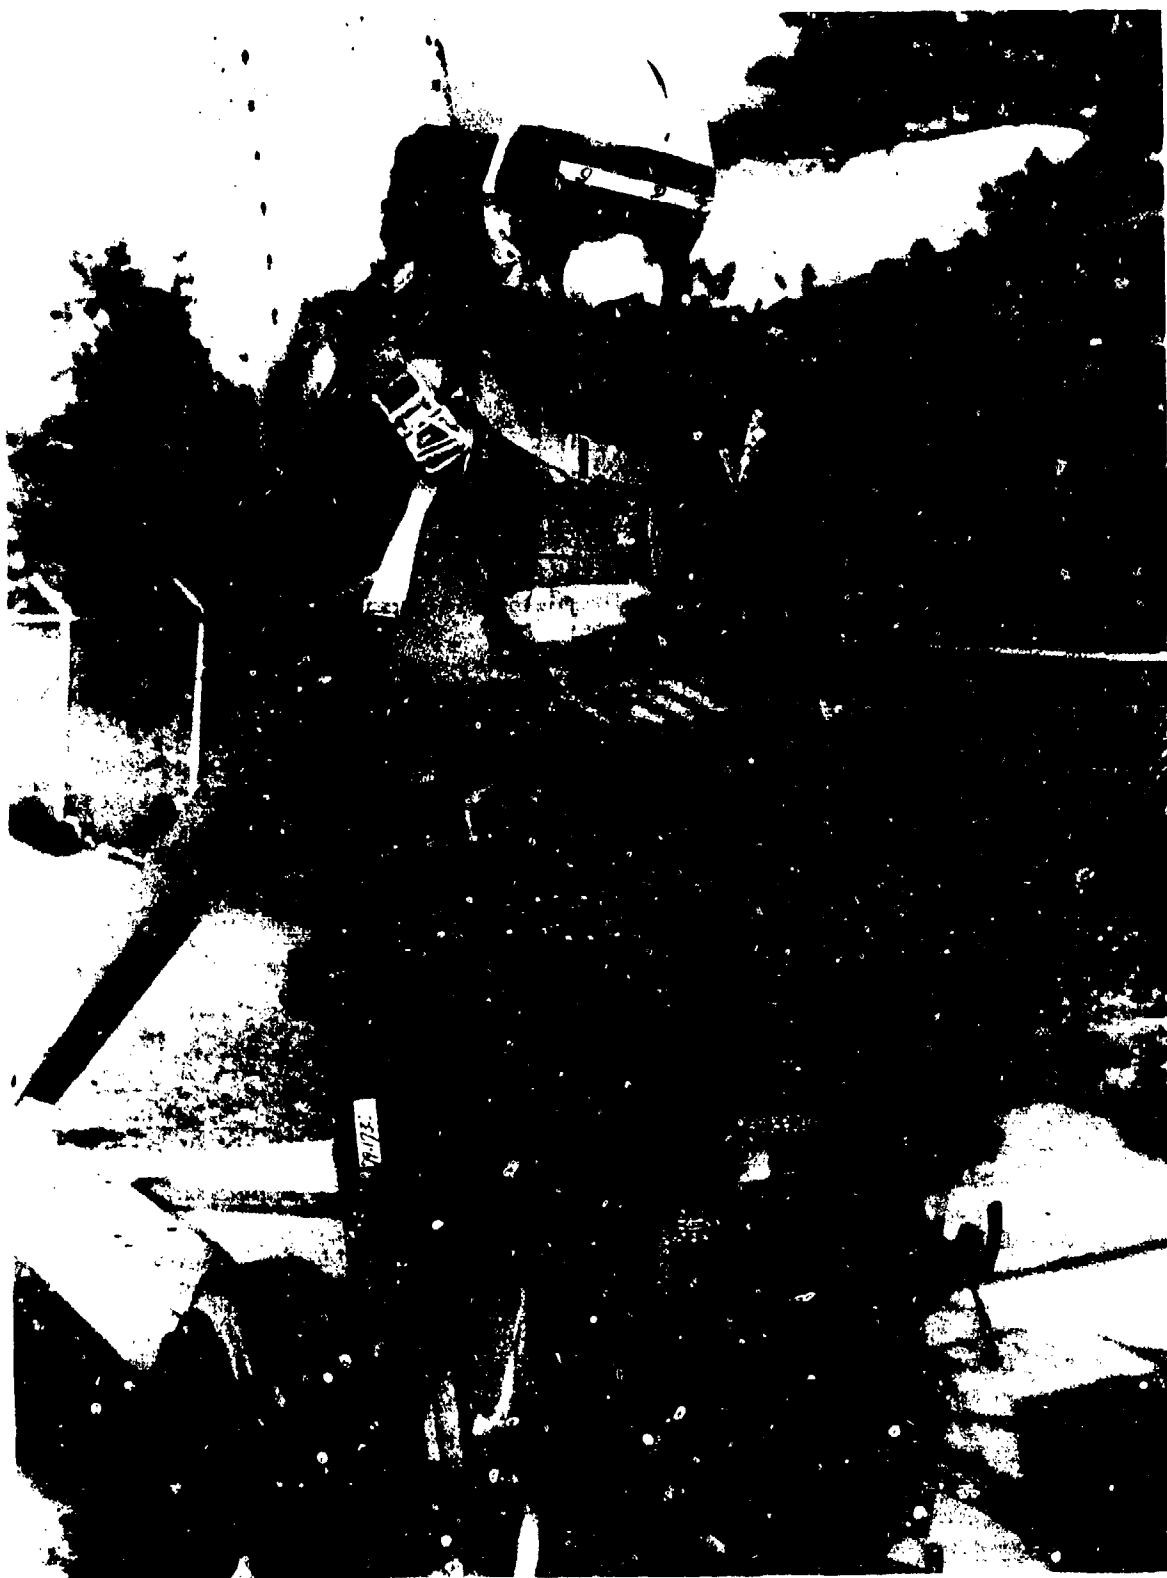
FIGURE 27 - Post Test Condition - 605 Knots Starboard Side

The right arm was perfectly retained in its original position (figure 27). The test however, was still considered very successful.
